Anterior rehabilitation using 3D-printed dental implants and custom-made immediate restorations through additive manufacturing.

Short Communication

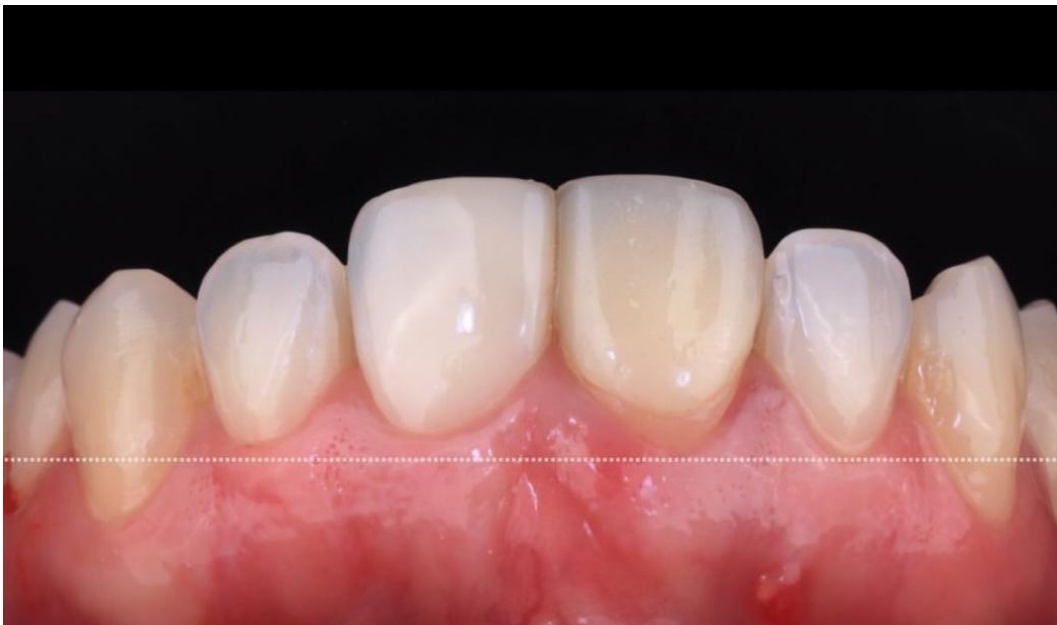
Figure. 1 - Aesthetic discomfort caused by an uneven gingival margin and significant gingival recession affecting the central incisor.

The patient's dental history indicated extensive prior treatments related to the trauma. These included an initially unsatisfactory endodontic procedure, which led to recurrent periapical infections, failed attempts at reprofiling and endodontic surgery, and three crown replacements due to persistent aesthetic and functional challenges. Furthermore, the patient expressed a primary concern regarding aesthetic discomfort caused by an uneven gingival margin and significant gingival recession affecting the central incisor (Figure 1). This issue was exacerbated by the patient's high smile line, which prominently exposed the affected gingival margin when smiling.

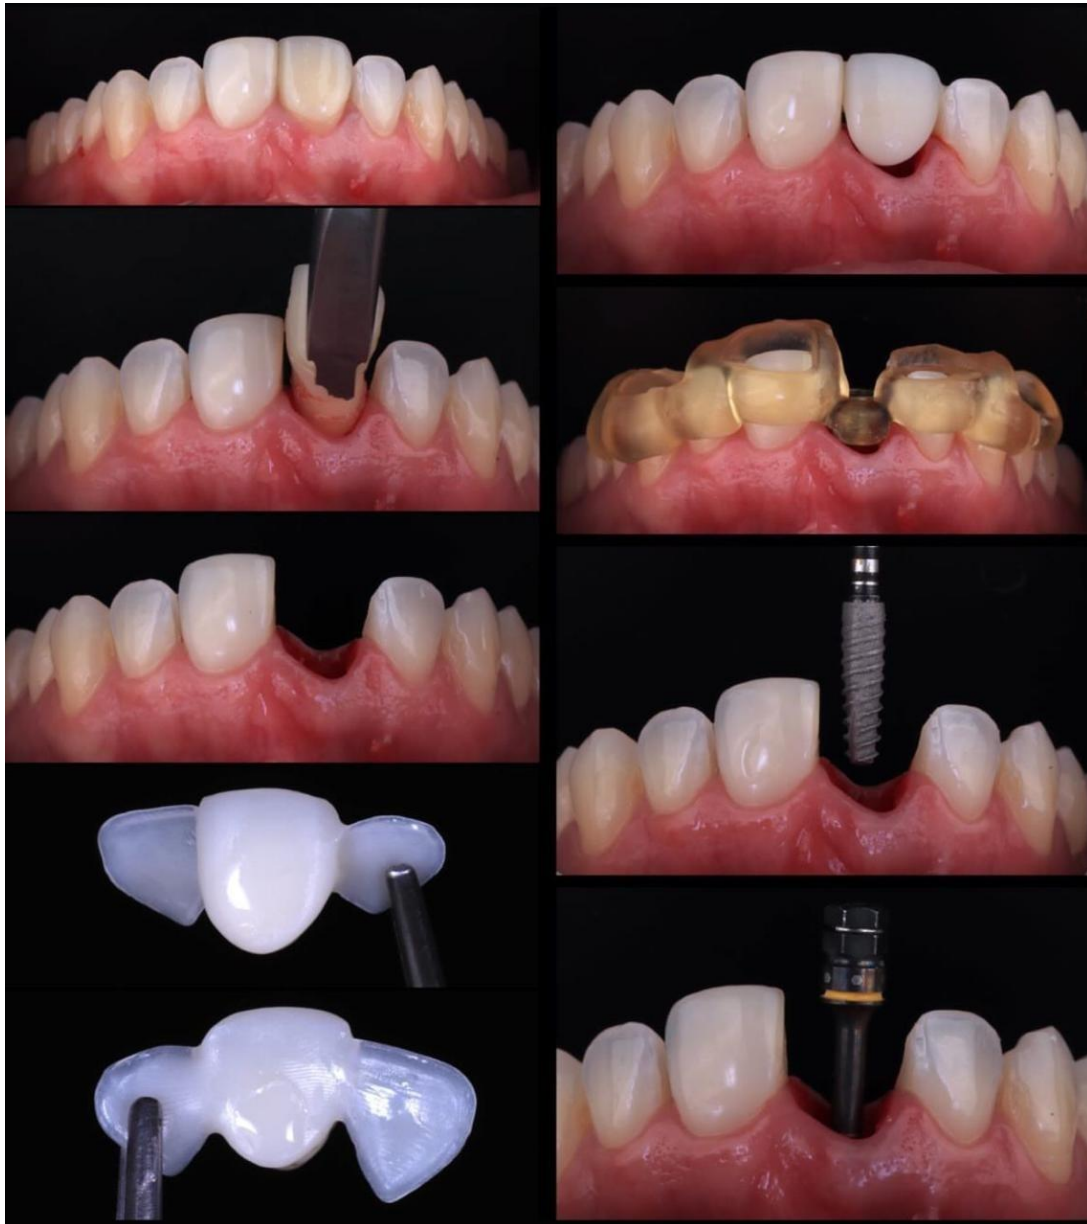
Figure. 2 – The extraction of the dental element was accompanied by procedures to restore and optimize the bone and soft tissue architecture in the region designated for implant placement.

administration of infiltration anesthesia in the vestibular and palatal regions of the affected area. Atraumatic extraction of the compromised tooth was performed without creating a flap, utilizing syndesmotomy and excision with a straight extractor. This approach aimed to preserve the gingival contour, maintain the papilla in position, and minimize bone loss (Figure 2).

After extraction, a pre-planned surgical guide (3D STUDIO – Plano Virtual da Face[®], Natal-RN, Brazil) was employed to assist in the alveolar bone osteotomy. This ensured the ideal implant positioning for future prosthetic rehabilitation. The guide utilized Cone Morse Guided Surgery sleeves (Plenum[®], Jundiaí-SP, Brazil). Subsequently, a 4.0 x 11.5 mm 3D-printed implant (Plenum[®], Jundiaí-SP, Brazil) was inserted into the central incisor site with a torque of 45 N (Figure 2).

Next, the left greater palatine nerve was anesthetized to facilitate the harvest of subepithelial connective tissue. The graft site was carefully delineated, and epithelial tissue was removed via dermabrasion using a #8 round diamond bur, leaving behind the connective tissue graft (Figure 2). The removal was performed without full-thickness excision to preserve a residual tissue layer over the bone, minimizing bleeding risk and enhancing patient comfort during healing.

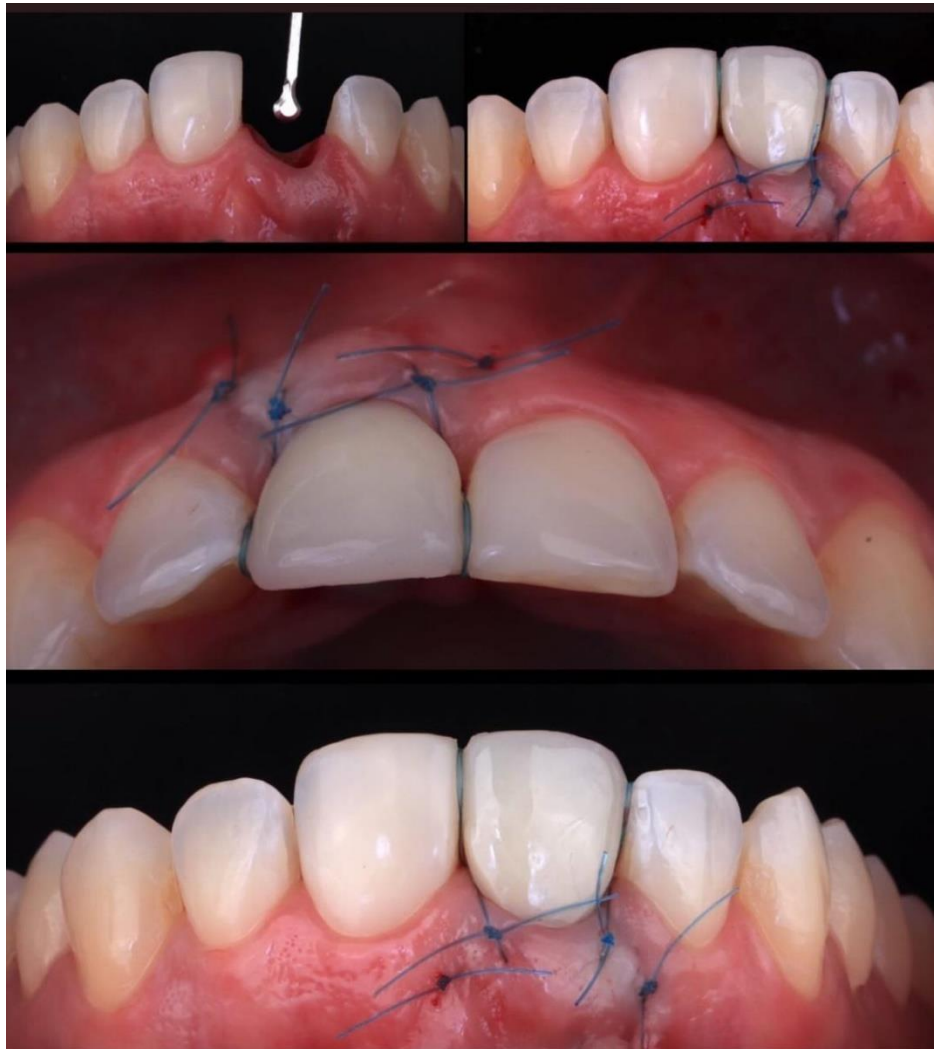
Figure. 3 - The connective tissue graft was placed internally to the flap and secured using 6.0 monofilament polypropylene sutures.

The anterior maxillary defect was then grafted with a biphasic bioceramic (HA/ β -TCP, 70:30) with a particle size of 500–1000 μ m (Plenum[®], Jundiaí-SP, Brazil). A resorbable poly(dioxanone)-based membrane (Plenum[®], Jundiaí-SP, Brazil) was adapted and positioned over the vestibular access (Figure 3). The connective tissue graft was placed internally to the flap and secured using 6.0 monofilament polypropylene sutures (Techsuture[®], Bauru-SP, Brazil). Finally, the soft tissues were sutured and stabilized

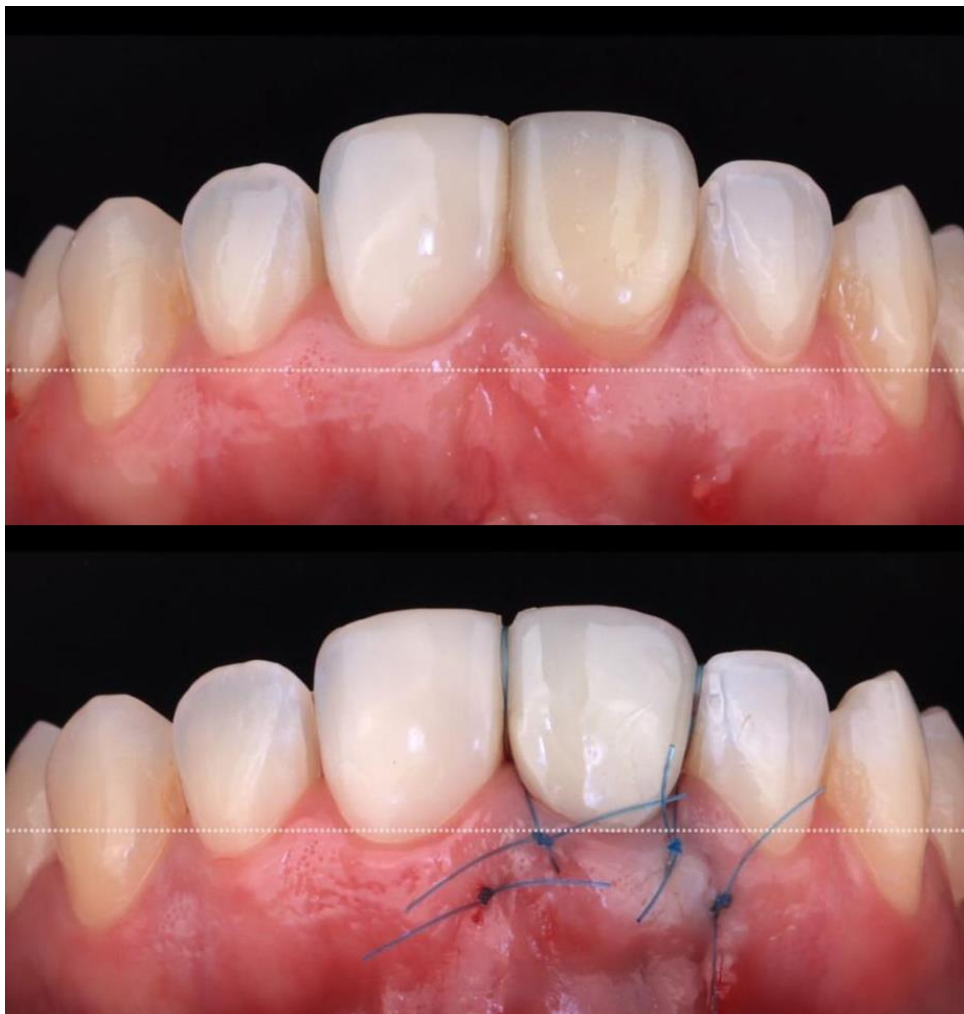
Figure. 4 – The final appearance of the fixed restoration on implant after the surgical procedure.

A temporary zirconia prosthesis was milled and sintered following precise manufacturing guidelines, with surface preparation involving ceramic primers and air abrasion. The prosthesis was cemented with dual-cure resin cement after proper light-curing. Veneer preparation included sulcular retraction, feather-edge design, and open-tray impressions. Both the crown and veneer were fabricated from high-translucency zirconia polycrystalline ceramic and underwent detailed color characterization. Adhesive cementation was performed under relative isolation, using etching and bonding techniques for both the tooth and ceramic surfaces. The restoration achieved excellent functional and aesthetic outcomes, with the patient reporting full satisfaction.
