Endodontic treatment of upper first premolar with 3 roots and 3 radiculars – Clinical case report

ESTUDO DE CASO

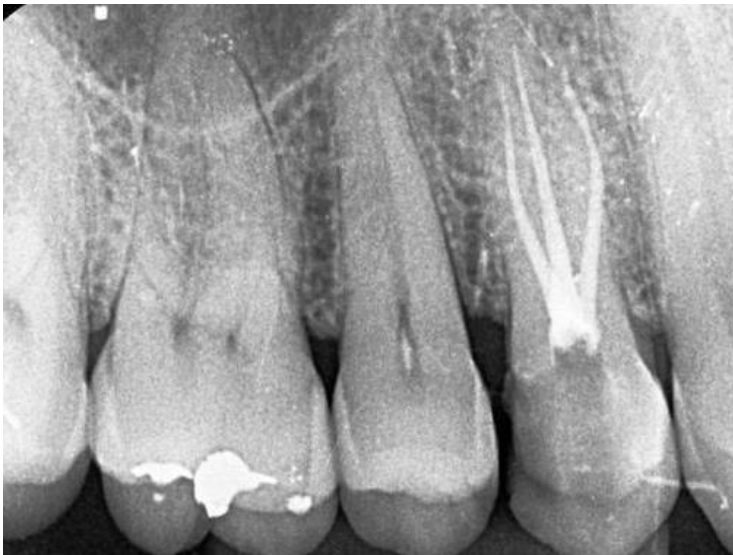
Figure 2 - Root canal filling was performed using the single cone technique.

Three canals were prepared using Sequence Niti rotary instruments (MK Life) to #25.06, and the root canals were irrigated with 2,5% sodium hypochlorite solution. Root canal filling was performed using the single cone technique associated with Bio-C Sealer cement and 25.06 taper gutta-percha tip were used. The postoperative X-ray showed that all the 3 canals were filled (Figure 2).
